**Settlement at the
Fleet Maintenance Building
Before and After Pictures and Lidar**

**Push Pier and
Polymer
Injection were
used to Stabilize
and Lift the Fleet
Building**

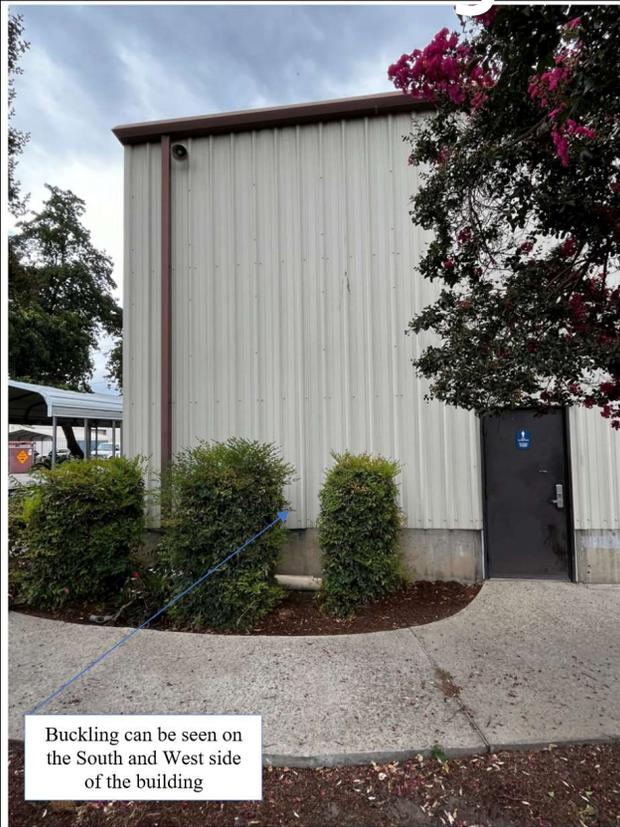
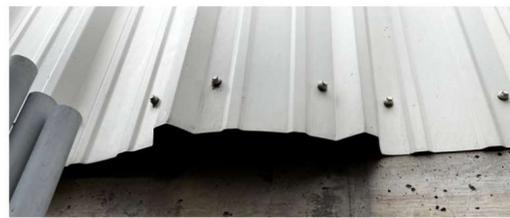
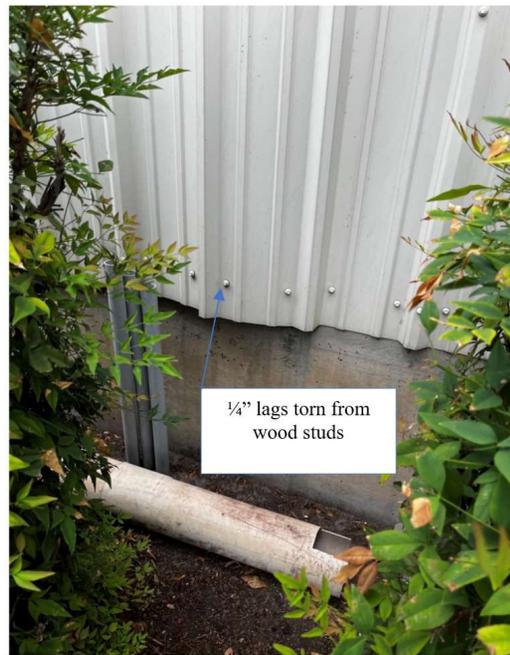
Before

Buckling of Siding Due to Settlement

Buckling of Siding Resolved After Lift

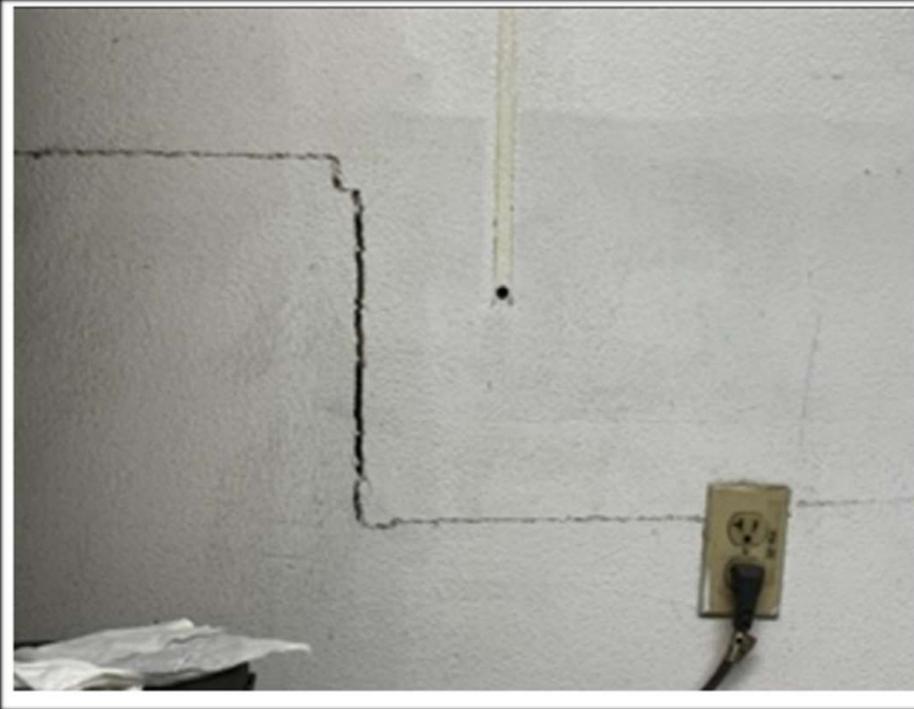
Before

Closing of Cracks Caused by the Settlement

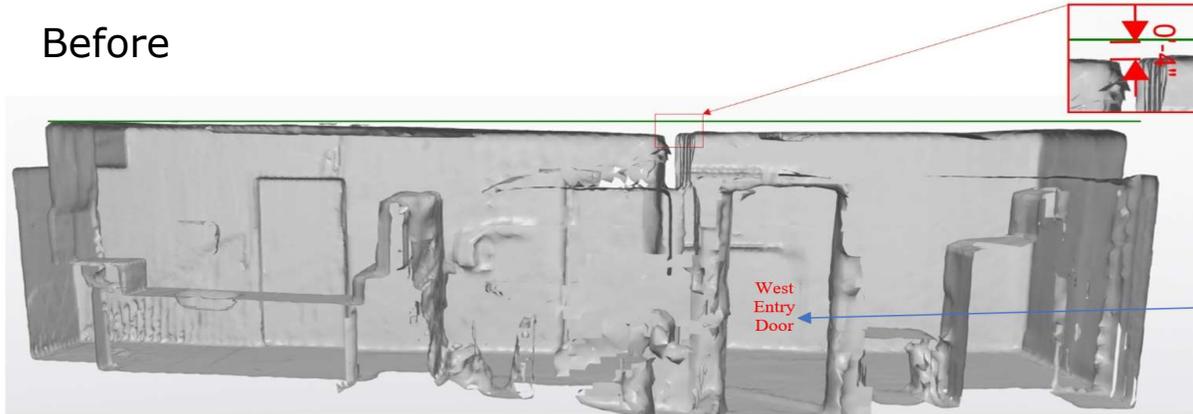
Before

Majority of settlement found at west entry door

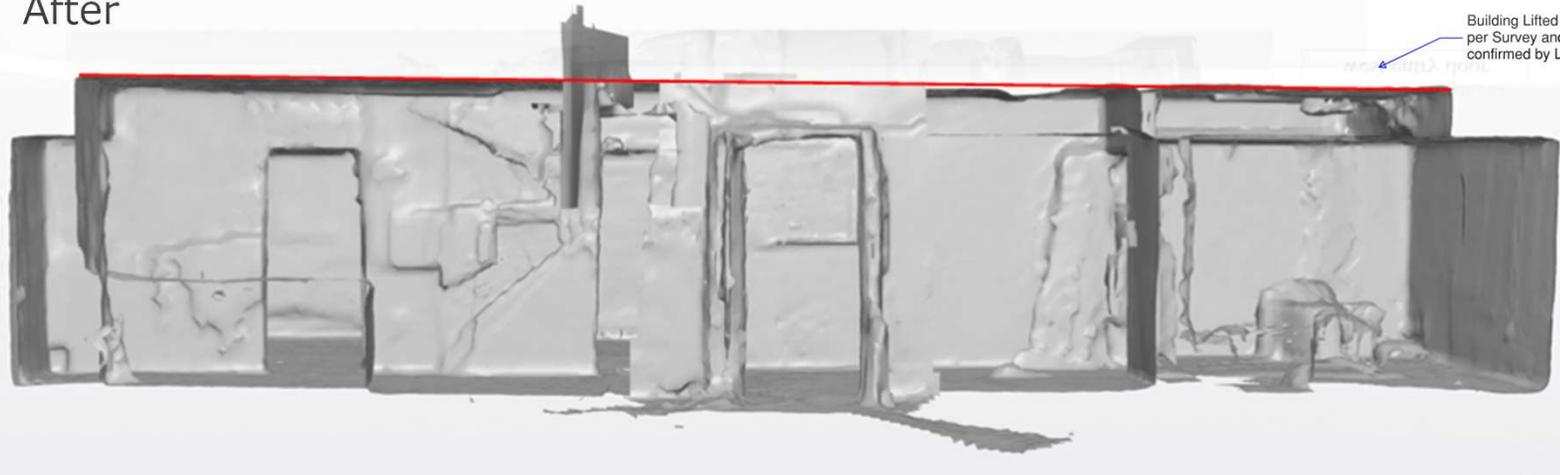
After

Building Lifted as per Survey and confirmed by Lidar
