# Visalia Water Reclamation Facility

**Facility Plan Update  
Council Presentation**

2/20/2024

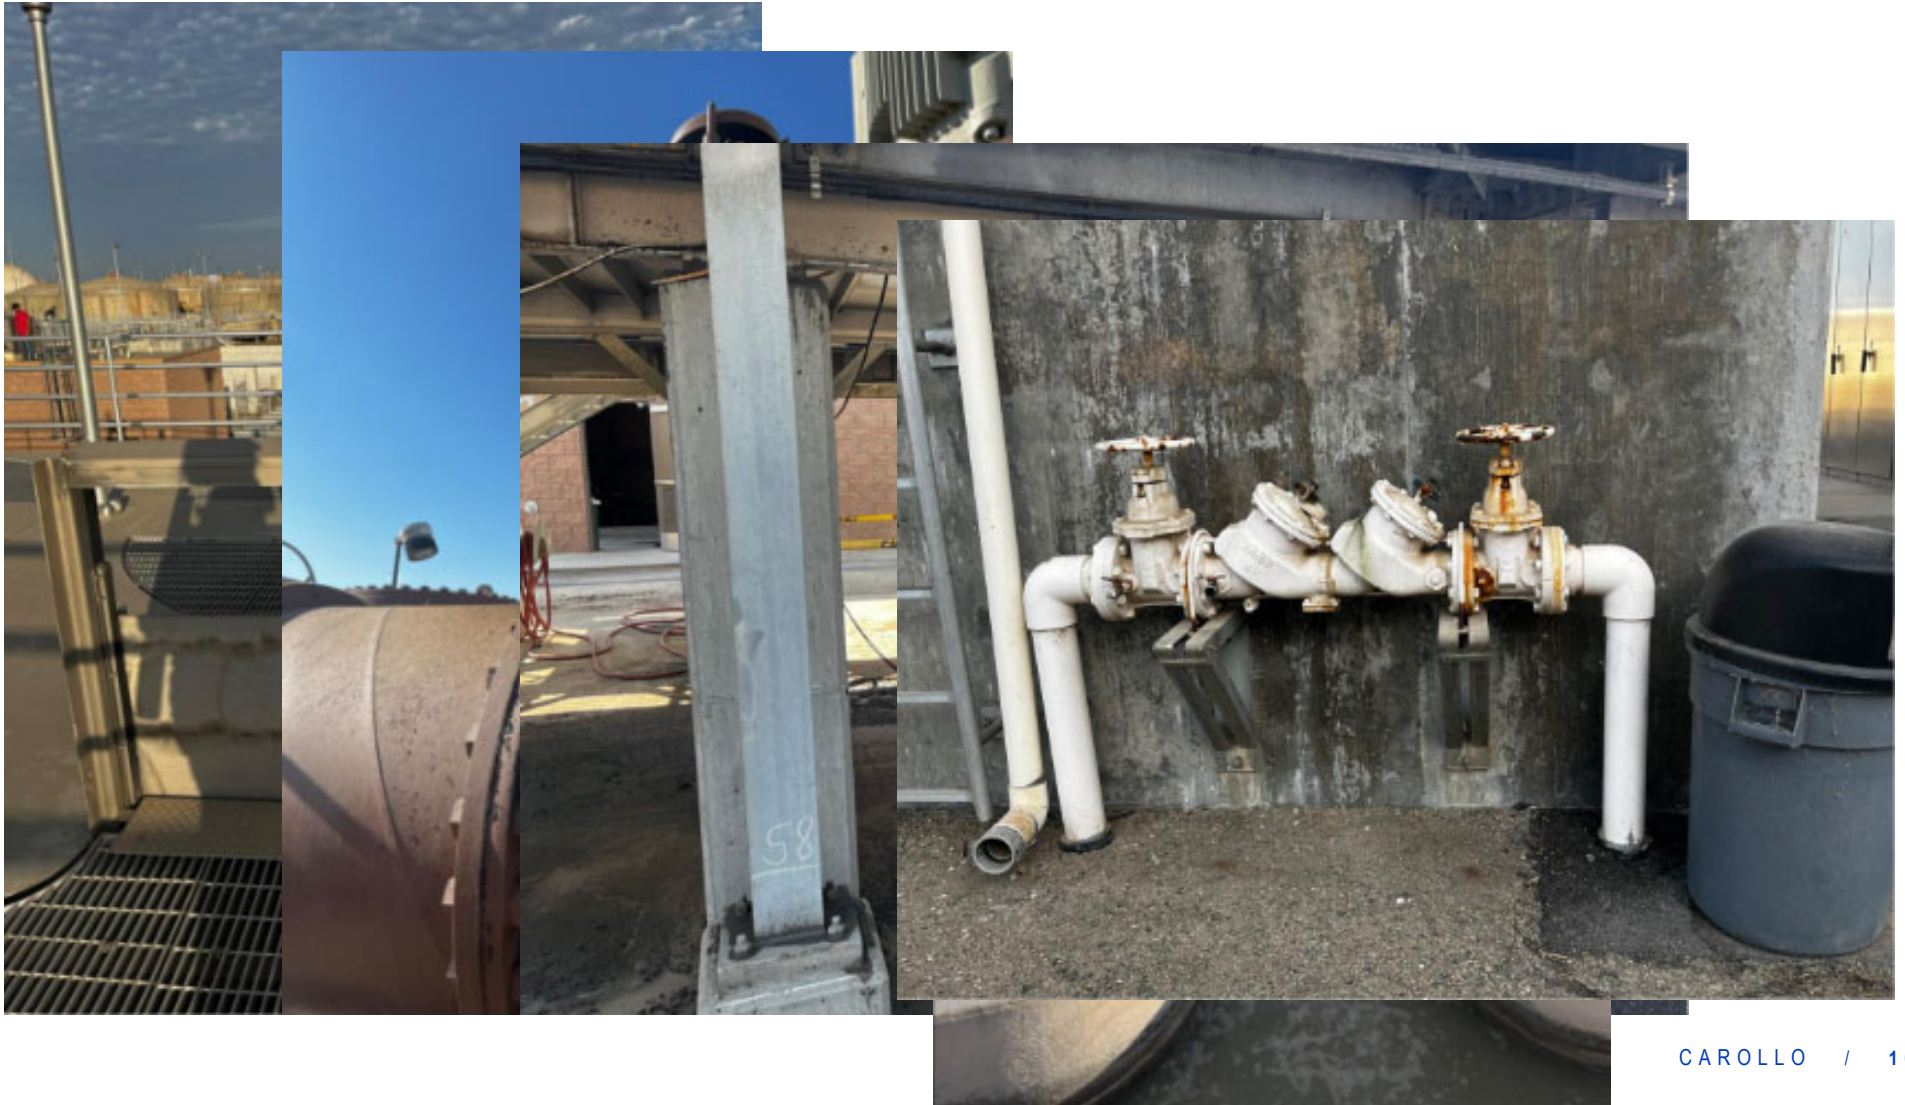
# Site Photos

- In general the equipment at the WRF is in good condition
- There were significant upgrades in the last improvement project and all of this equipment is in good condition
- The following areas need some attention:
  - » Headworks
  - » Digesters
  - » Sludge Drying beds
  - » Misc. piping/pumps/valves

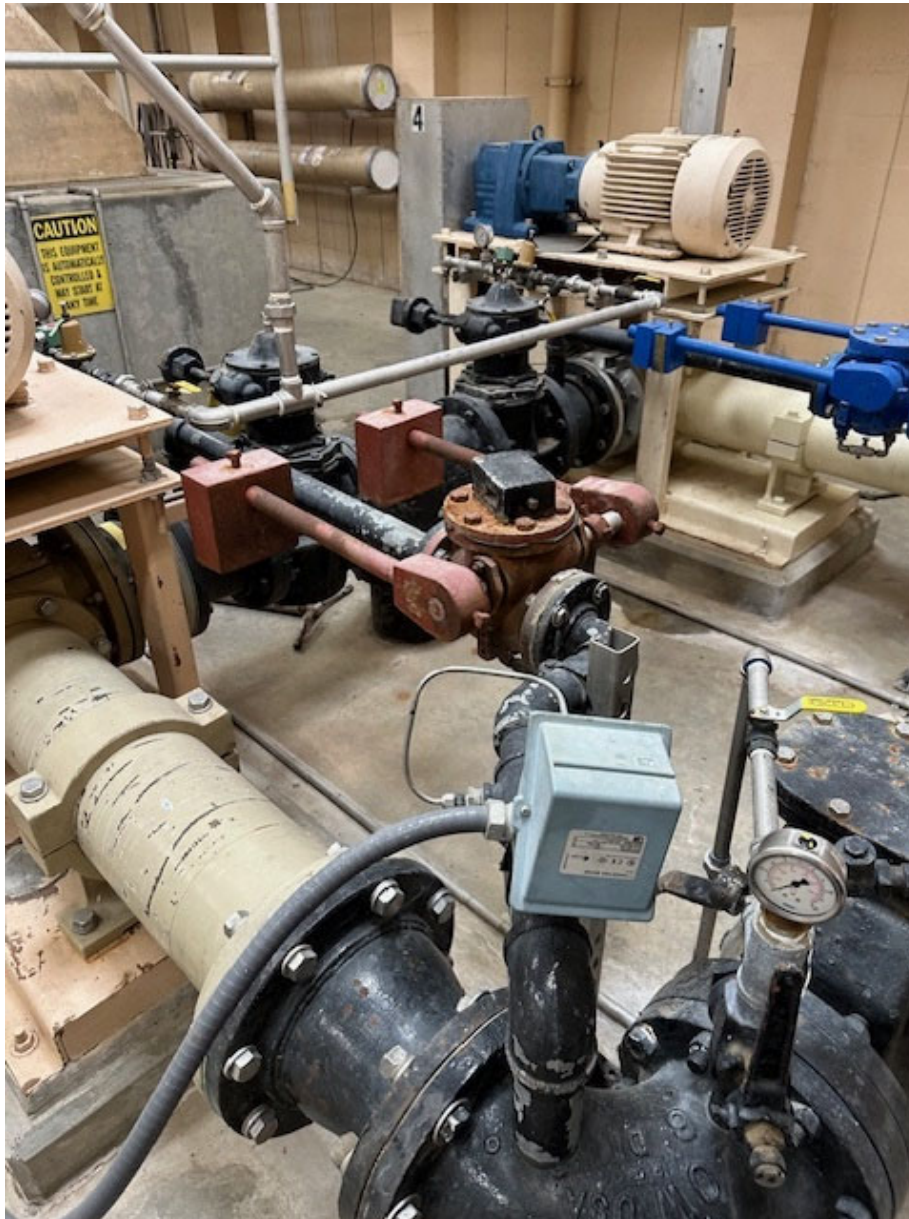
# TWAS Pump Station Upgrades

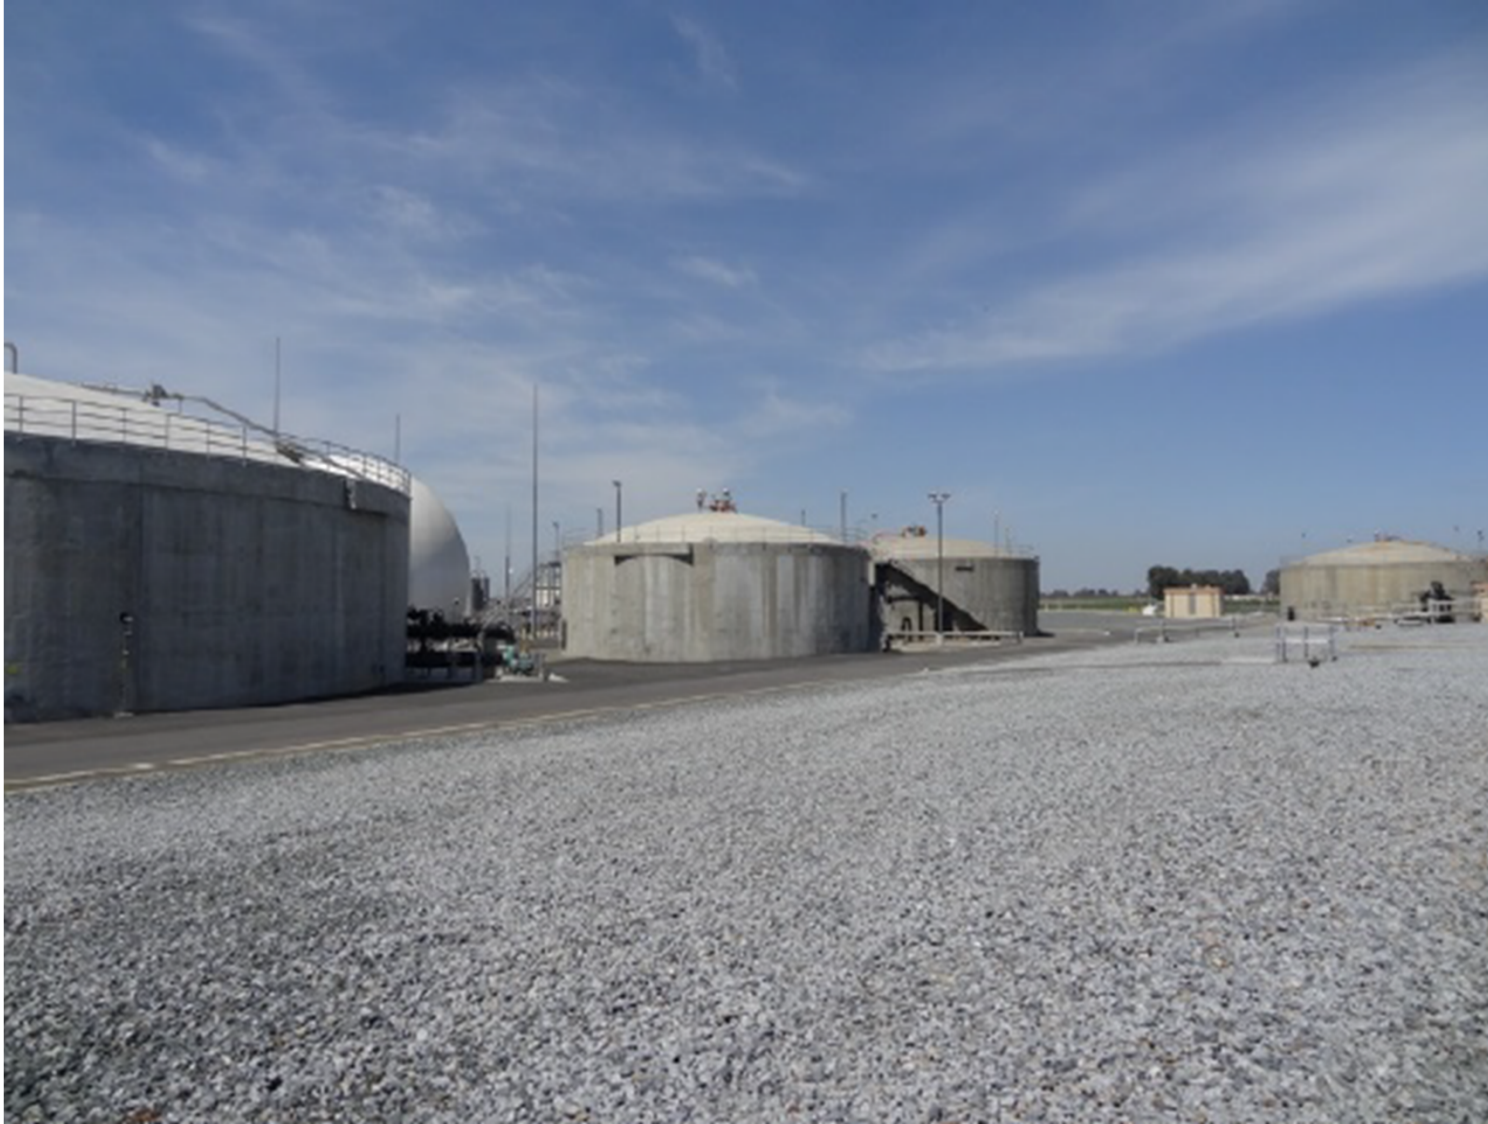
# Digester Upgrades

- Place Dig No. 4 back in service (waiting on piping)
- Continue tracking digester health parameters and develop response plan for early signs of failure
- Clean/de-grit digesters that have not been cleaned recently (i.e. last 2-4 years)
- PS and TWAS pumping modifications and/or replace discharge piping
- Re-purpose Dig #8 as a primary digester (Currently used as 70% storage)
- Additional digester volume likely needed to accommodate future growth to buildout

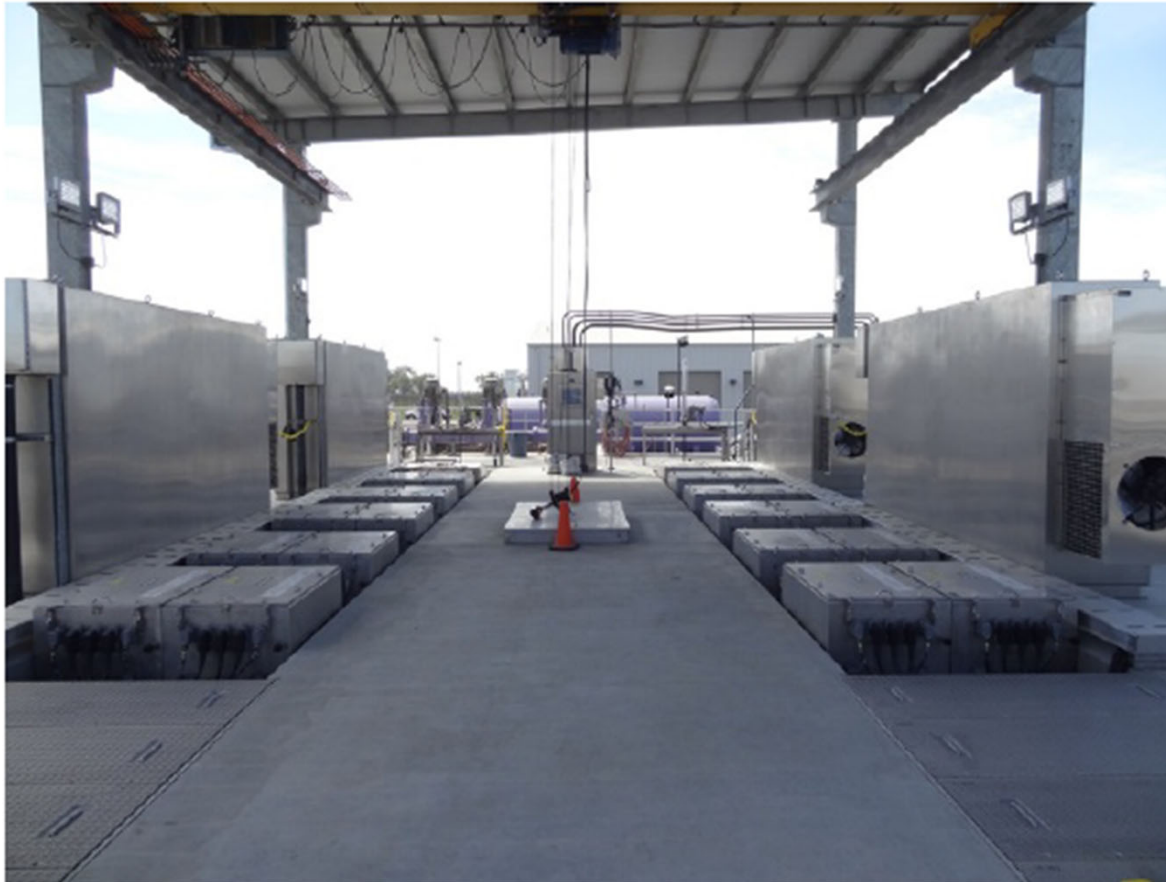
- Additional UV bank unit needed to provide redundancy/standby
